Software Release Note

RD-002-05

Project Title: EKO / e24 / TEKO Dimmer

This document is a cumulative list of bug fixes and feature enhancements for EKO V2/V3 family of products.

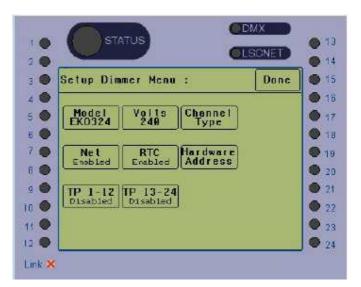
This brings up the Service Menu. Press the Setup Button to access the Setup Menu.

Check that the model matches the model you have just upgraded. If it doesn't press the Model button and select the appropriate dimmer model.

Check that the Dimmer Volts is set appropriately. (No harm will occur if you set this inappropriately; the worst that will happen is that the 120V curve will be hidden in the curves menu).

Verify that the channel type matches the channels as installed in the Dimmer. If they don't, then set them appropriately.

If no LSCnet Power Supply is installed or you do not require LSCnet functionality then set Net Enabled to False.

If you are having issues with the Real Time Clock, Disable it.
